LUNCH AND LEARN
DAM SAFETY PRESENTATION
*REGULATORY REQUIREMENTS FOR DAM
ENGINEERING ASSESSMENTS IN NEW YORK*
Allan Estivalet, PE

NEW YORK STATE DAM SAFETY REGULATIONS

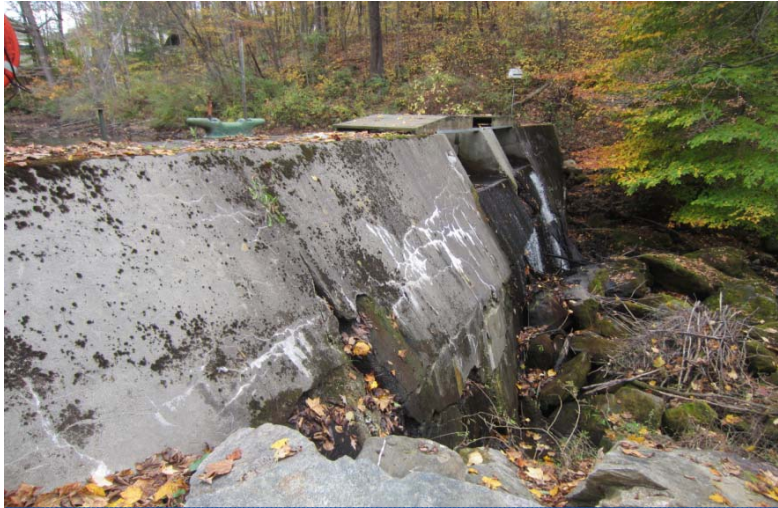
Louis Enten Pond Dam #1, Putnam Valley, NY

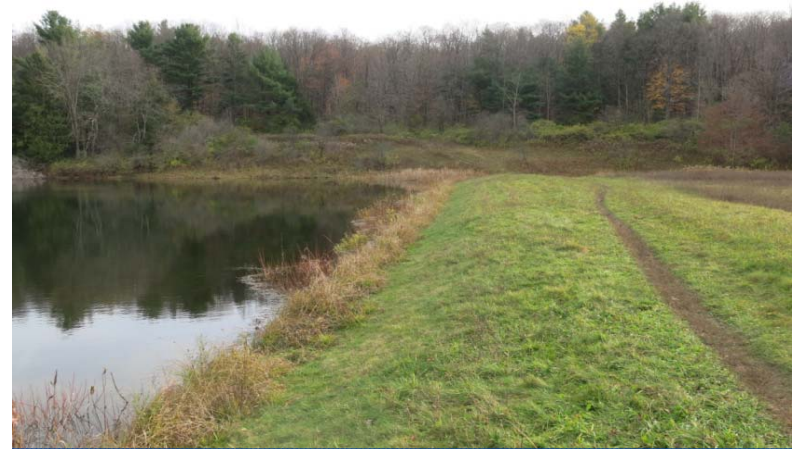
Madison Reforestation Dam , Town of Nelson, NY

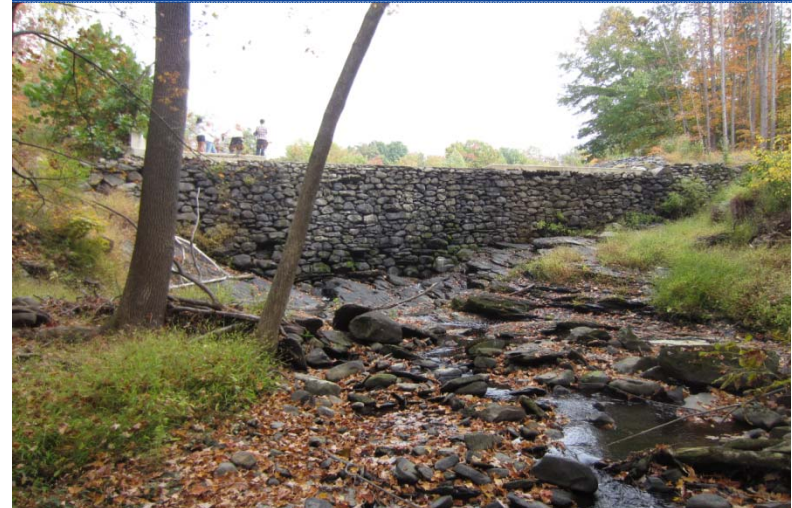
Schoonmaker Lake Dam, Blooming Grove, NY

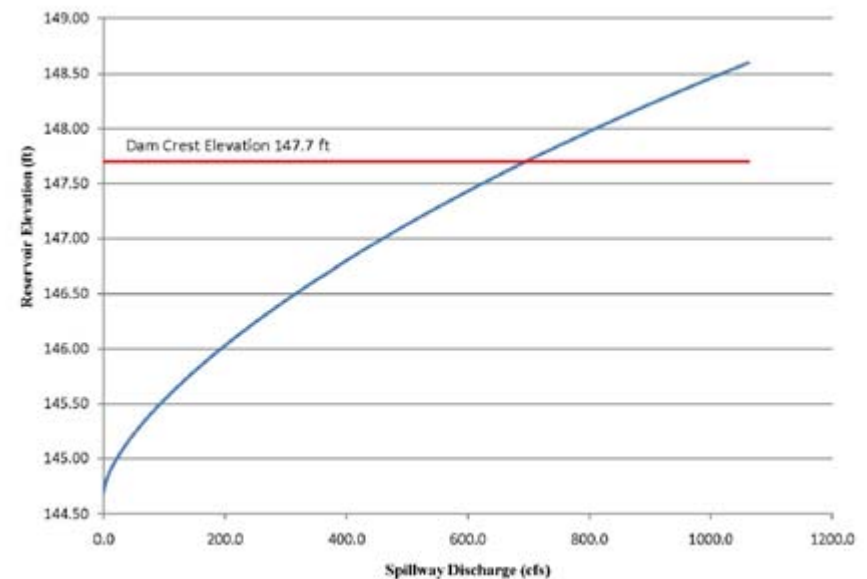
- The spillway should have adequate capacity to pass the Spillway Design Flood (SDF)
- Assuming no inflow, the spillway should have sufficient discharge capacity to evacuate 75% of the storage between the maximum design high water and the spillway crest within 48 hours.
- Velocities in spillway should not exceed the maximum permissible velocities (non-erodible velocities) of the spillway materials.

Hazard Classification	Spillway Design Flood (SDF)
A	100 year
B	150% of 100 year
C	50% of PMF

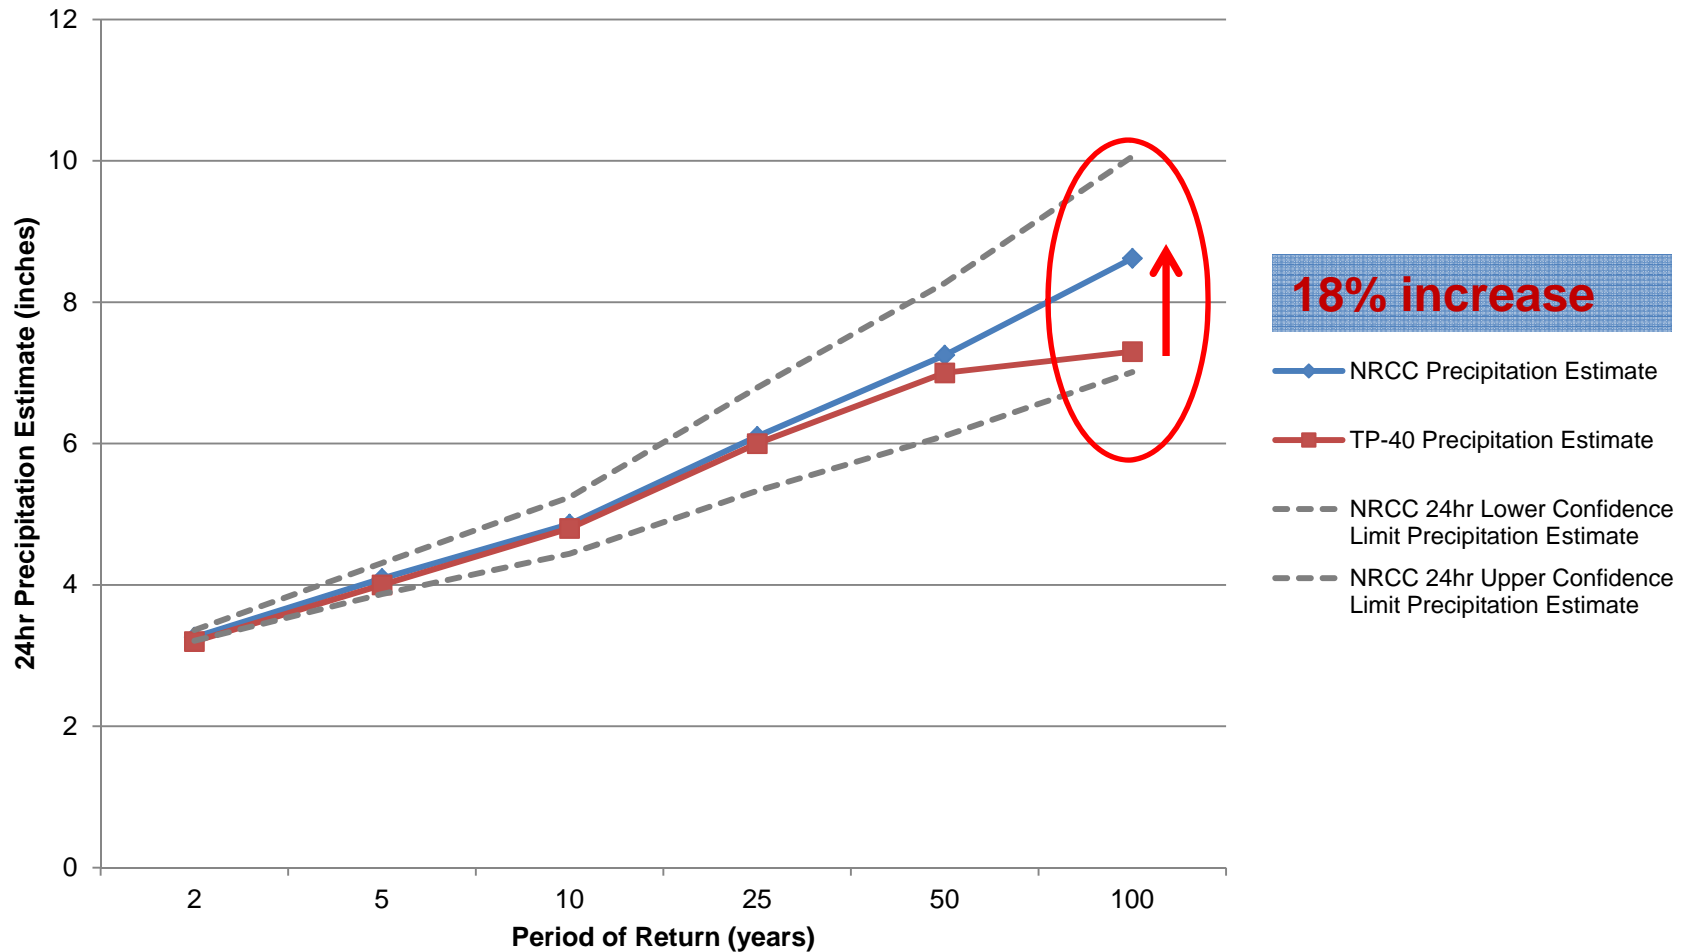
Comparison of Precipitation Estimates according to NRCC and TP-40 for 100 Year 24 Hour Rainfall in Westchester County, NY

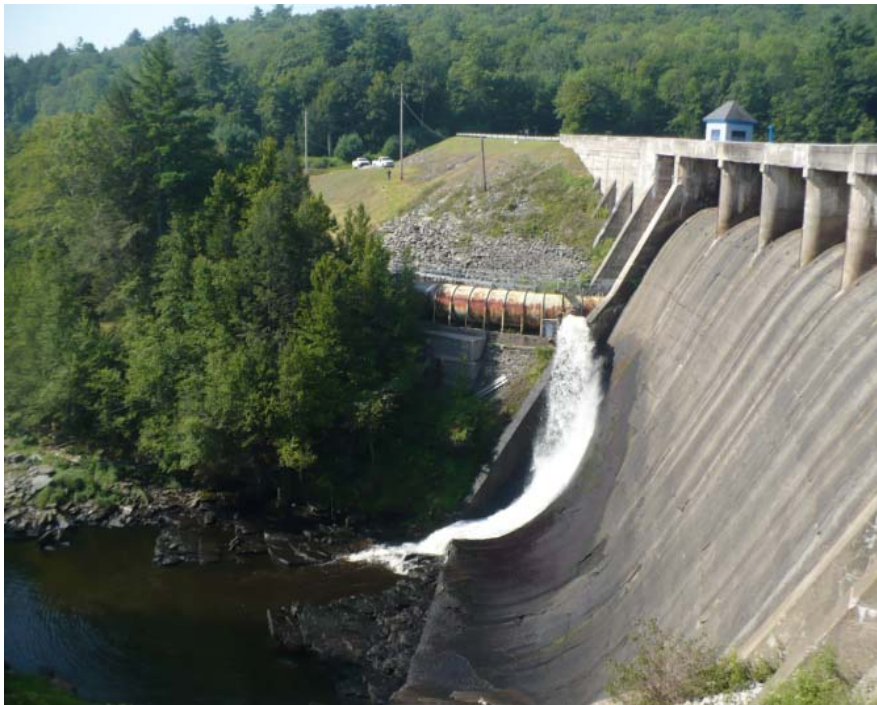
Rio Dam Project, Forestburgh, New York (2014-ongoing)
Computational Fluid Dynamic (CFD) Flow 3D analysis

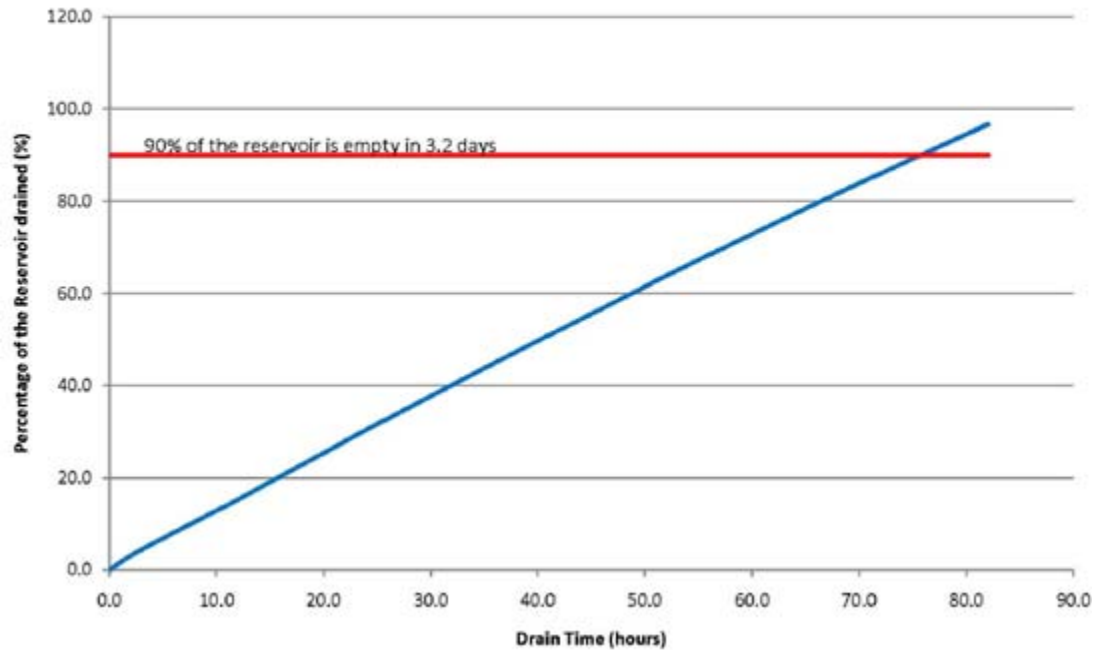
Evaluation of the dam's outlet works (reservoir drain) capacity

Wilkie Dam Gate House, Margaretville,
New York

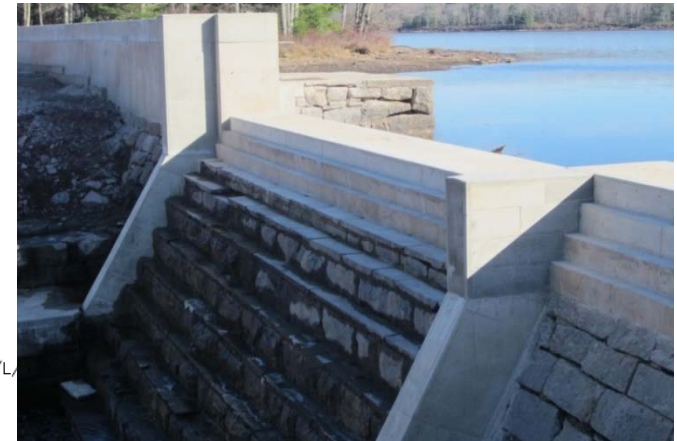
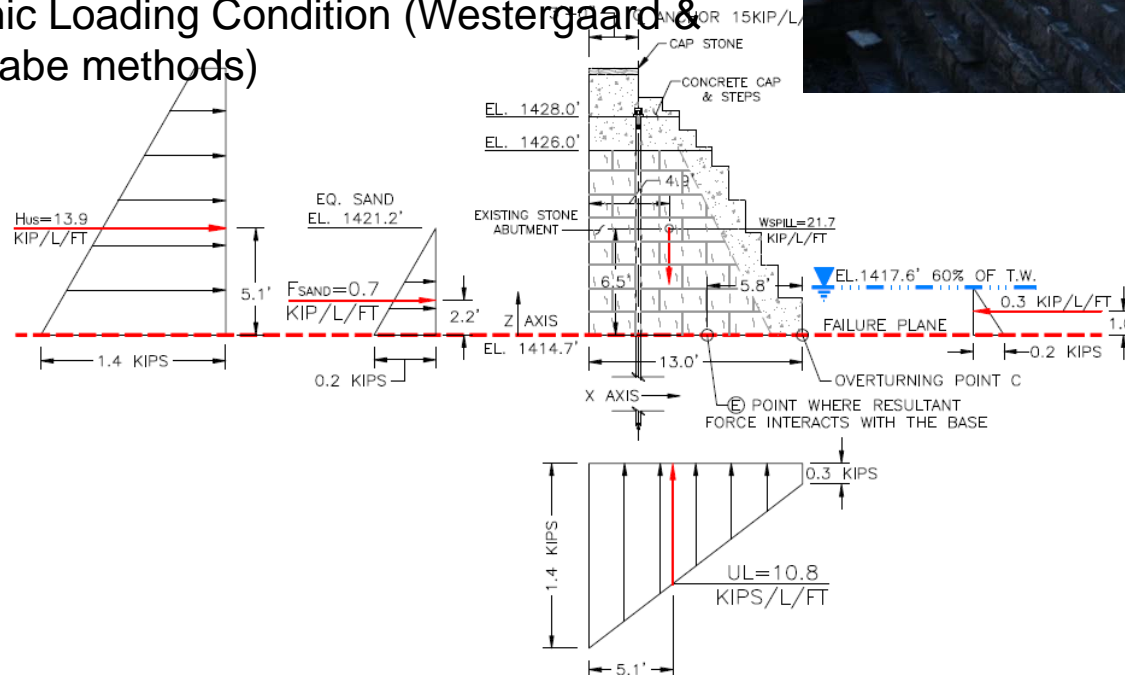
Evaluation of the dam's structural stability for the following loading cases:

- Case 1: Normal Loading Condition
- Case 2: Normal Loading Condition + Ice
- Case 3: Spillway Design Flood Condition (SDF)
- Case 4: Seismic Loading Condition (Westergaard & Mononobe-Okabe methods)

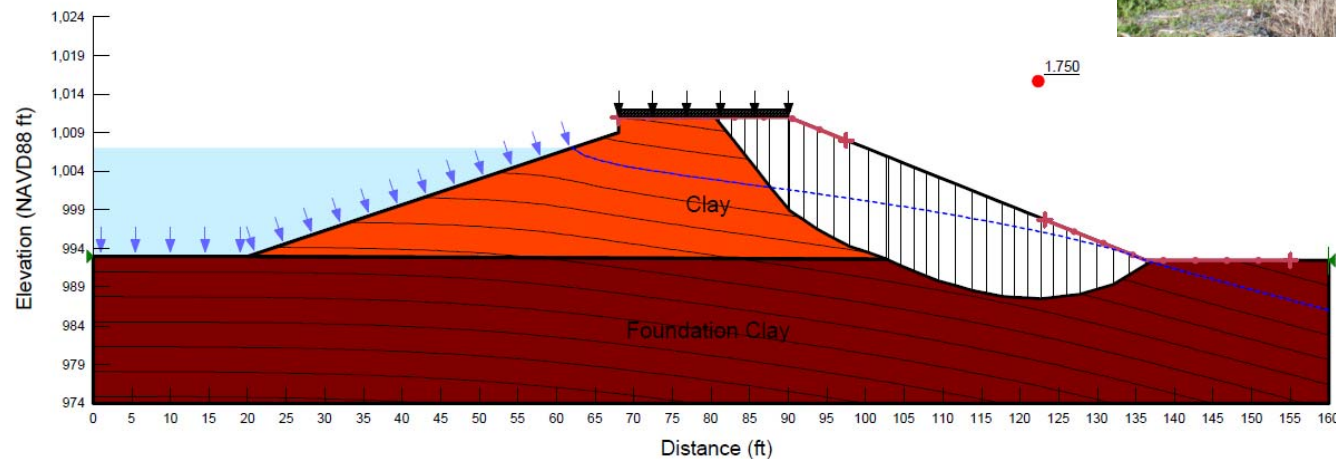
- Case 1: Normal Loading Condition (steady seepage)
- Case 2: Spillway Design Flood Condition (steady seepage)
- Case 3: Sudden drawdown
- Case 4: Earthquake/liquefaction

Chauncey Stillman Embankment Dam, Amenia, New York
Subsurface investigation & embankment slope stability analysis

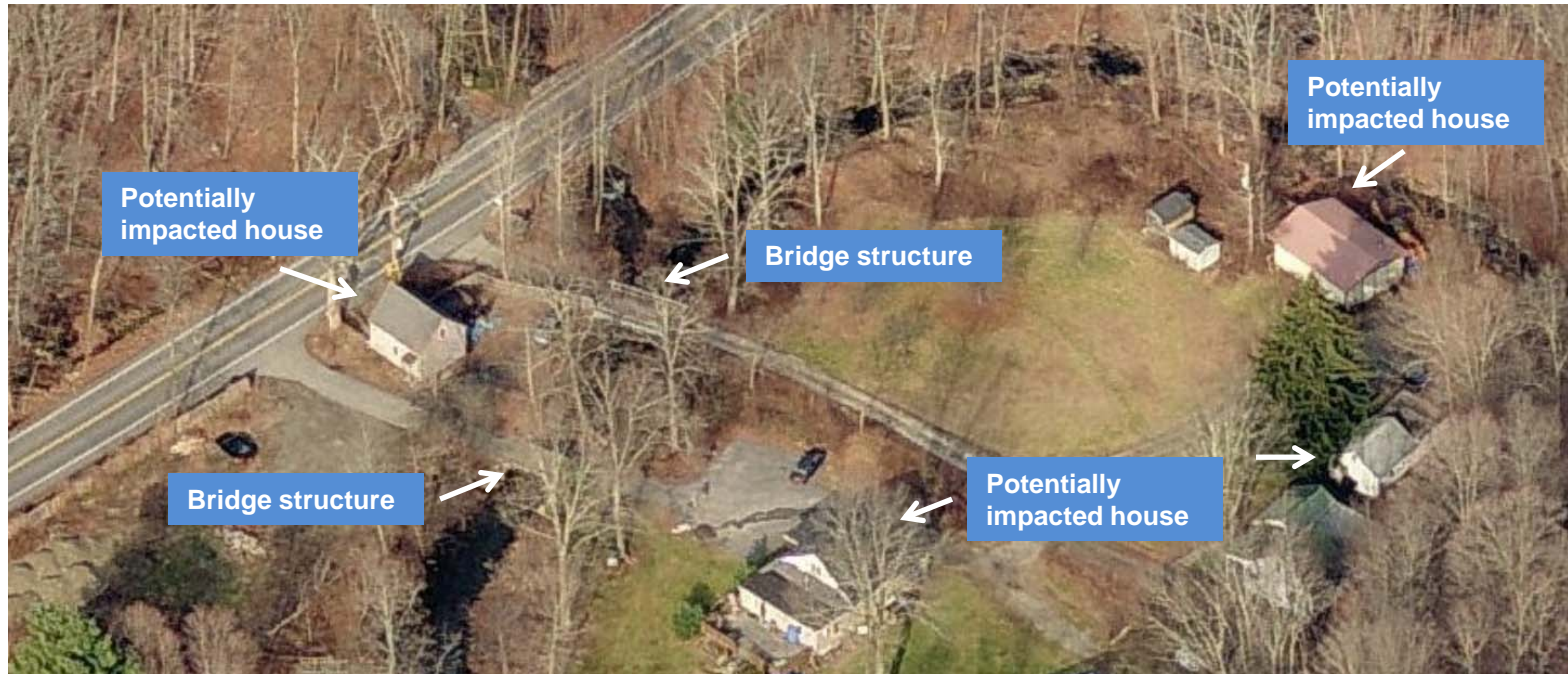
➤ Desktop review of the area downstream from the dam

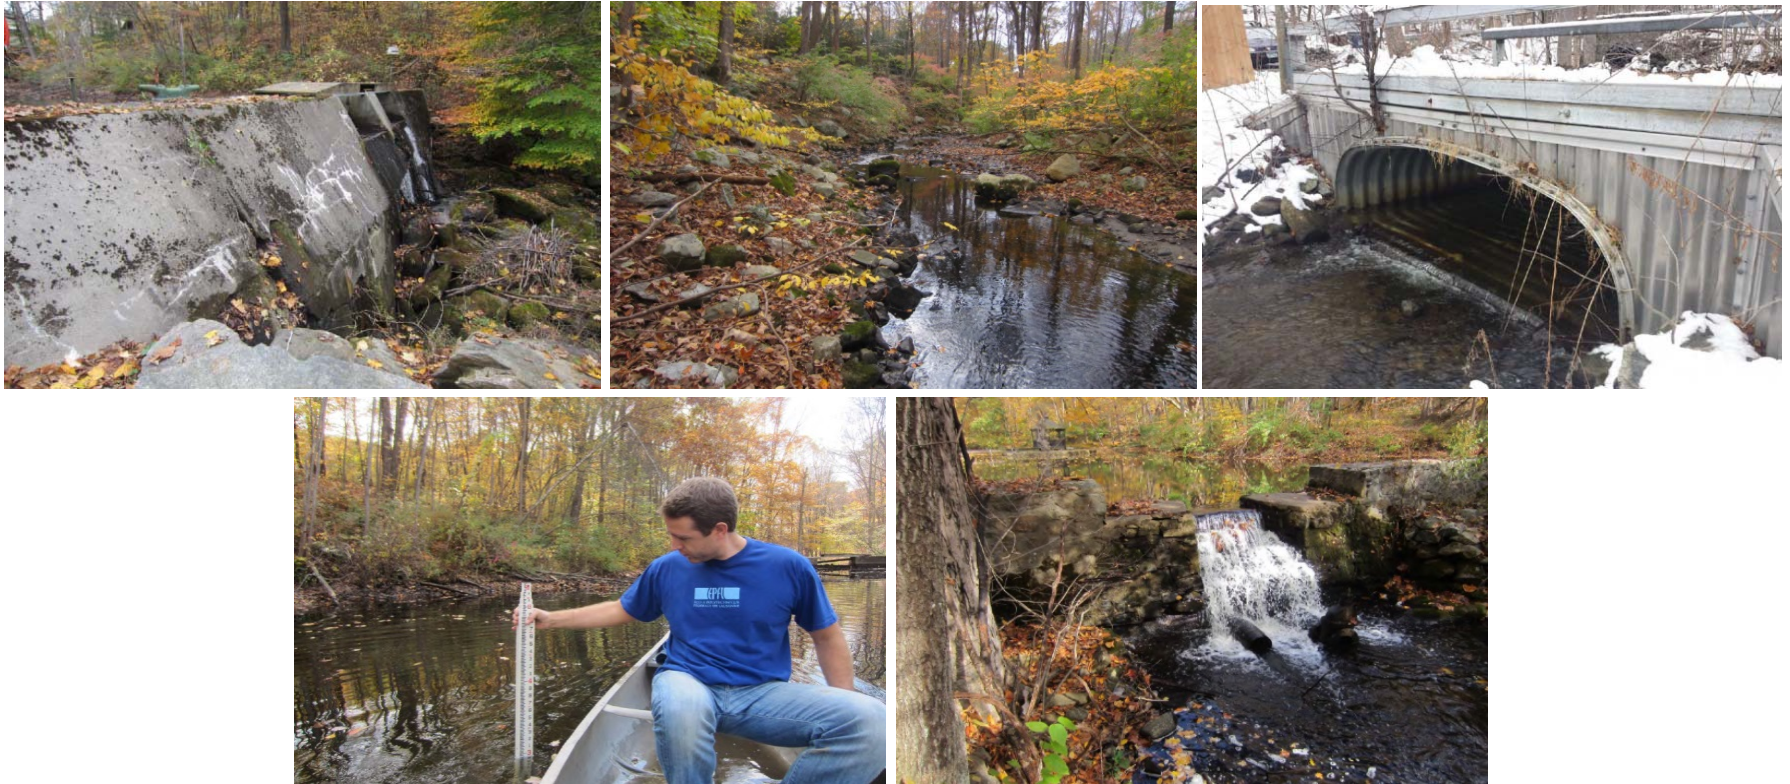
➤ River reconnaissance/data collection

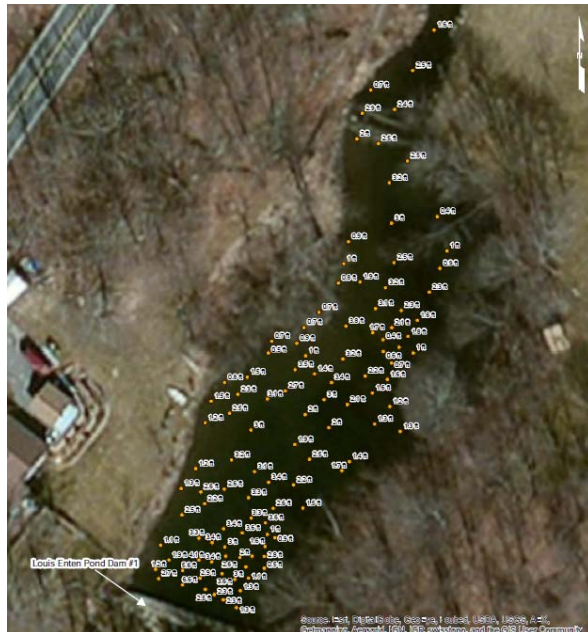
Bathymetric survey data data

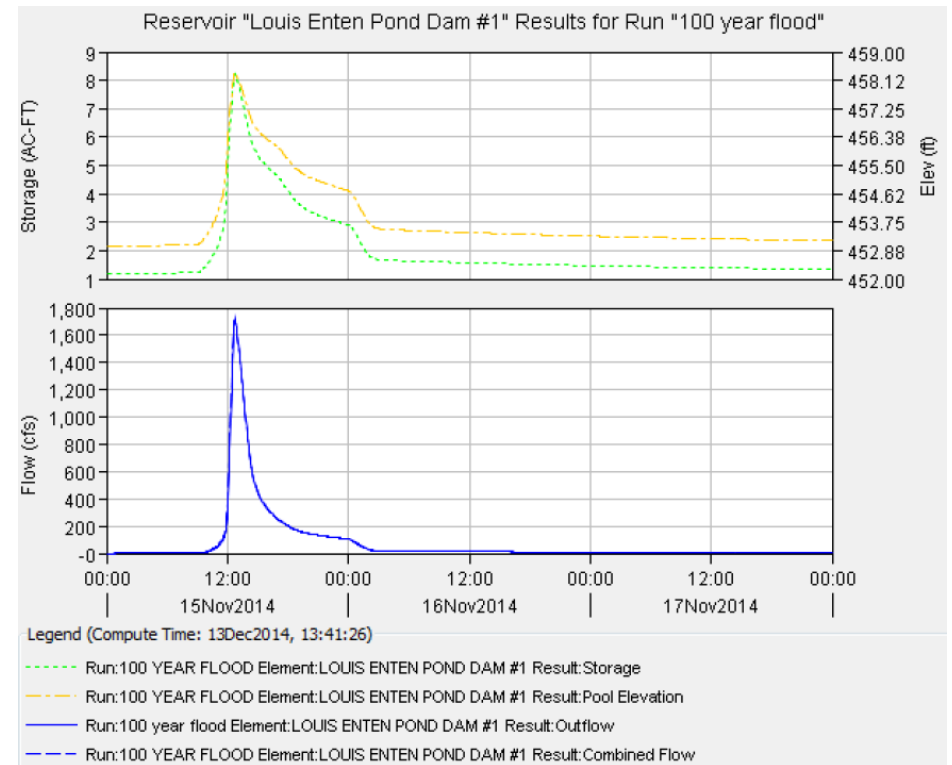
Flood Hydrograph at the dam (HEC-HMS output)

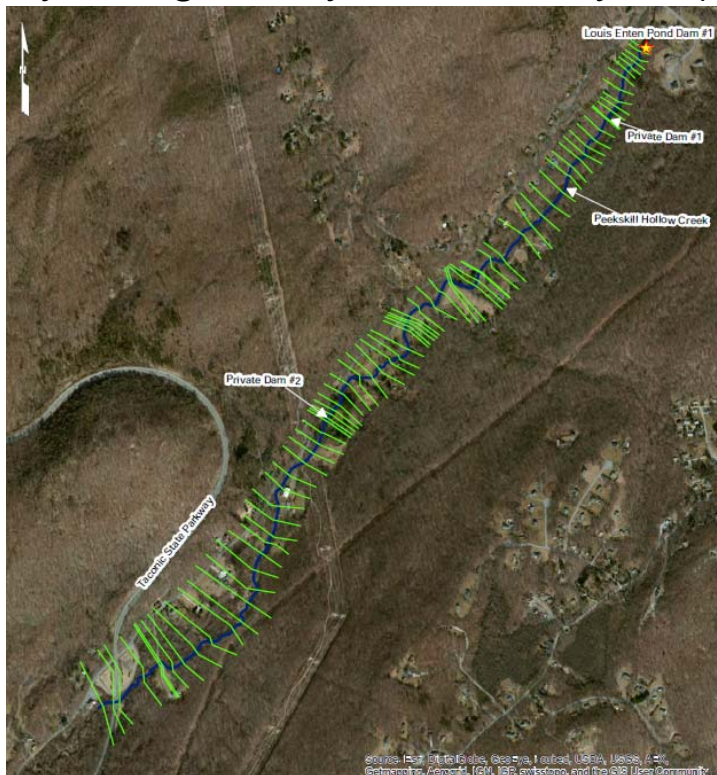
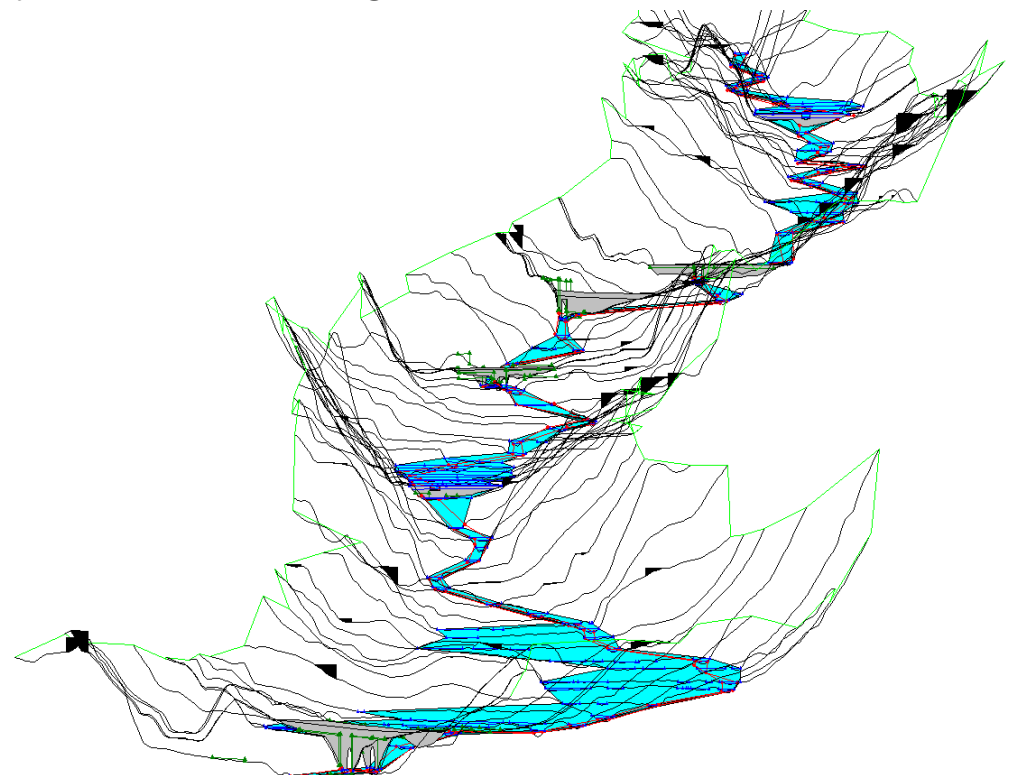
Peekskill River – HEC-RAS Model
